INTRODUCTION

The Grand Jury conducted an investigation into the September 10, 2018 failure of a portion of the Revolution Pipeline in Center Township, Beaver County, resulting in pollution to Raccoon Creek and its unnamed tributaries. The Revolution Pipeline traverses southwestern Pennsylvania and was designed to transport natural gas. It was the project of ETC Northeast Pipeline, LLC (“ETC”), a wholly owned subsidiary of Energy Transfer, LP (“Energy Transfer”). During this 18-month investigation, the Grand Jury received testimony from numerous witnesses including landowners in the pipeline fracture area, current and former employees involved in the construction and oversight of the pipeline project, members of the Pennsylvania Department of Environmental Protection and the Beaver County Conservation District, as well as Special Agent Bruce Gearhart of the Pennsylvania Office of Attorney General Environmental Crimes Section. The Grand Jury also reviewed voluminous documents obtained through its investigative resources, including expert reports commissioned after the pipeline failure. Finally, the Grand Jury was educated on the statutes that the legislature enacted in order to prot

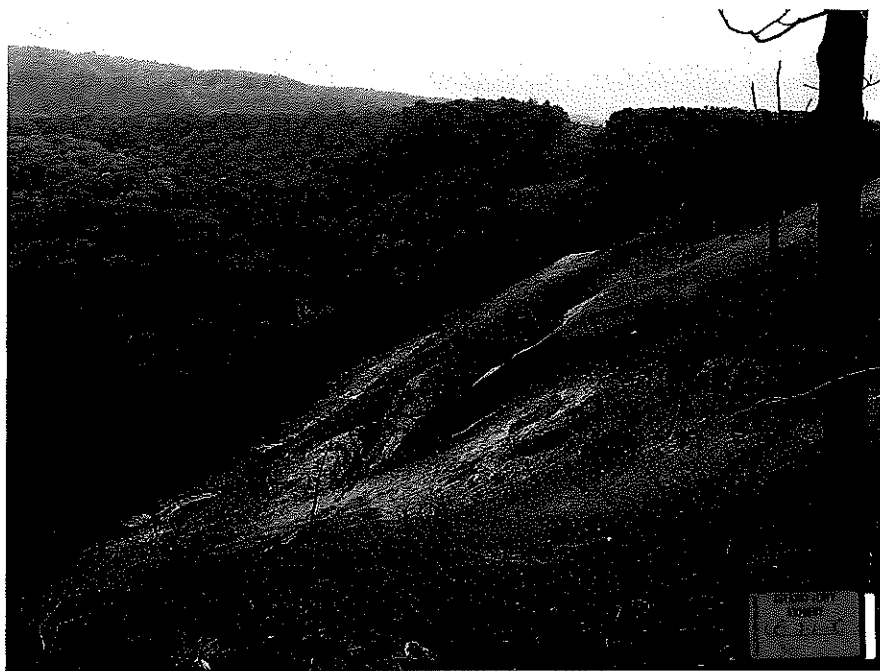
The Grand Jury heard testimony that on September 10, 2018, just before 5:00 a.m., a landslide occurred on the pipeline right-of-way, approximately one-half mile away from the intersection of Ivy Lane and Broadhead Road in Center Township, Beaver County, Pennsylvania. The landslide originated from unstable areas within the Revolution Pipeline limit of disturbance at that location. The limit of disturbance on a project is the area pre-determined by the permit that sets the boundaries of the project. All land disturbance must stay within that area. The landslide overtopped erosion control devices beyond the limits of disturbance and caused a discharge of sediment into Raccoon Creek. When the landslide occurred, a section of the Revolution Pipeline separated. Gas escaped from the pipeline and subsequently ignited. The resulting inferno caused devastation to the area that immediately surrounded it. The family whose home was closest to the fire was awakened by the sound of loud roaring, like a freight train and an “orange glow as bright as day”. The family members were only able to escape their home with the clothes on their backs. Their home, barn and multiple vehicles were incinerated. Other residents in the area had to evacuate their homes, as well. Over two acres of mature trees burned into piles of ash, and six high-voltage transmission towers collapsed.

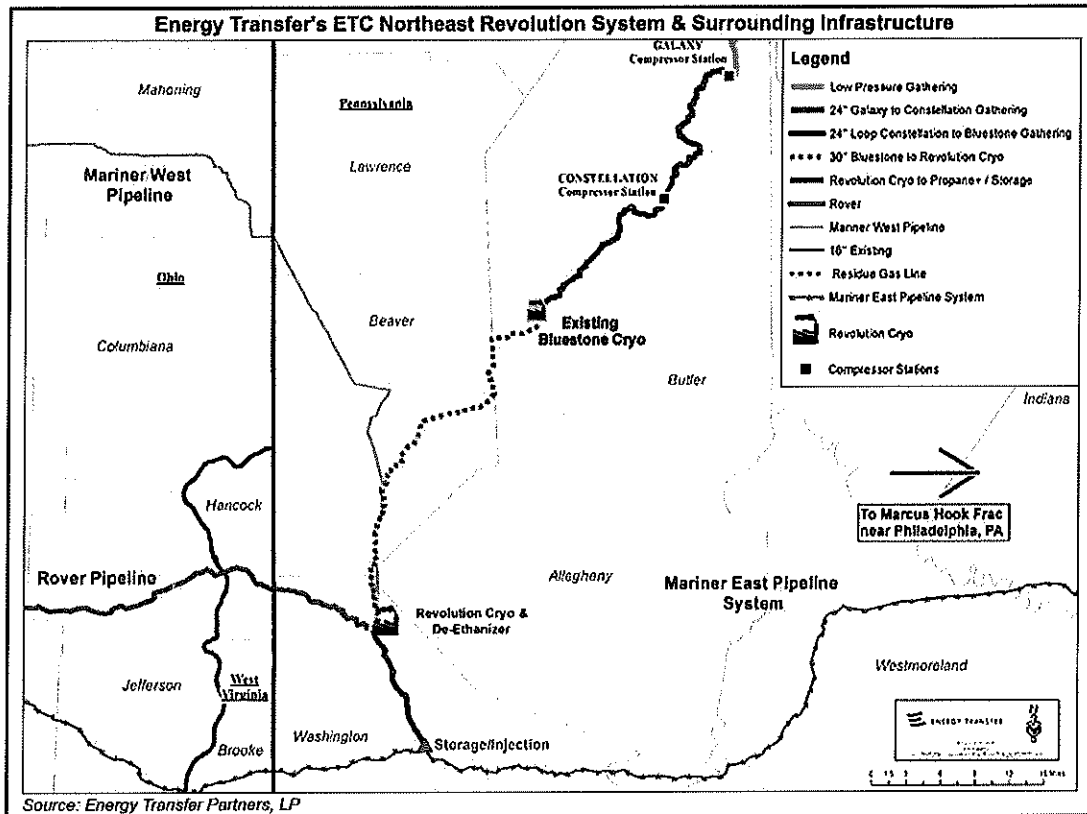
The Revolution Pipeline is a 42-and-a-half mile, 24-inch pipeline that starts in Butler County and is routed through Beaver County and Allegheny County before ending at a gas processing plant in Washington County. Because of the size of the project, it was divided into two “spreads” for installation purposes, with each spread spanning a particular geographical region of southwestern Pennsylvania.

Each spread had its own primary construction contractor and environmental inspectors. Spread 1 started in Butler County and ran south through Beaver County to the Ohio River. Spread 2 started at the Ohio River and ran south through Allegheny County to the Energy Transfer's gas processing facility in Washington County.

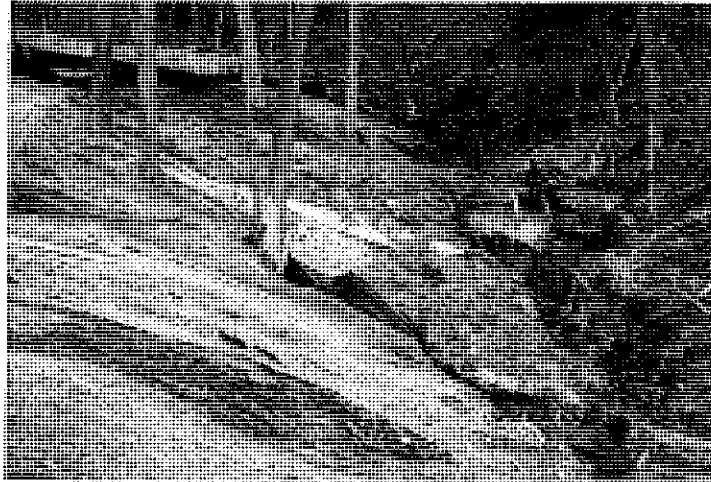
Backbone Road

Additional slips occurred at the Backbone Road, 1631+00-1643 site. A daily EI report from April 18, 2018 described the slips as follows:

Multiple slips on the CIS and the GAS of perennial stream 9-36 at station 1641+90 continues to deteriorate. ROW in this section is very wet and saturated and on the CIS of the stream is an area just below the recent anomaly dig up that was never fully restored. Due to the time of year, wet soil conditions and steepness of the slope the crew rough graded back the travel lane and the dig up area installing temporary water bars and mulching with the intention of permanently stabilizing later in the year when the weather allows. In addition on the edge of the CIS of the stream on the east side of the ROW within an STWS site a slip re-occurred that was once repaired. ON the GAS of the stream, a slip originating on the east edge of the ROW slipping down to the stream. This stretch was restored but significant water bar repairs and re-grading.
