INTRODUCTION

The Grand Jury conducted an investigation into a house explosion that occurred on October 31, 2018 in Greene County that seriously injured three people. The house, which belonged to the White family, was situated at 161 Bowser Road in Clarksville, directly in the middle of extensive infrastructure related to the oil and gas industry.

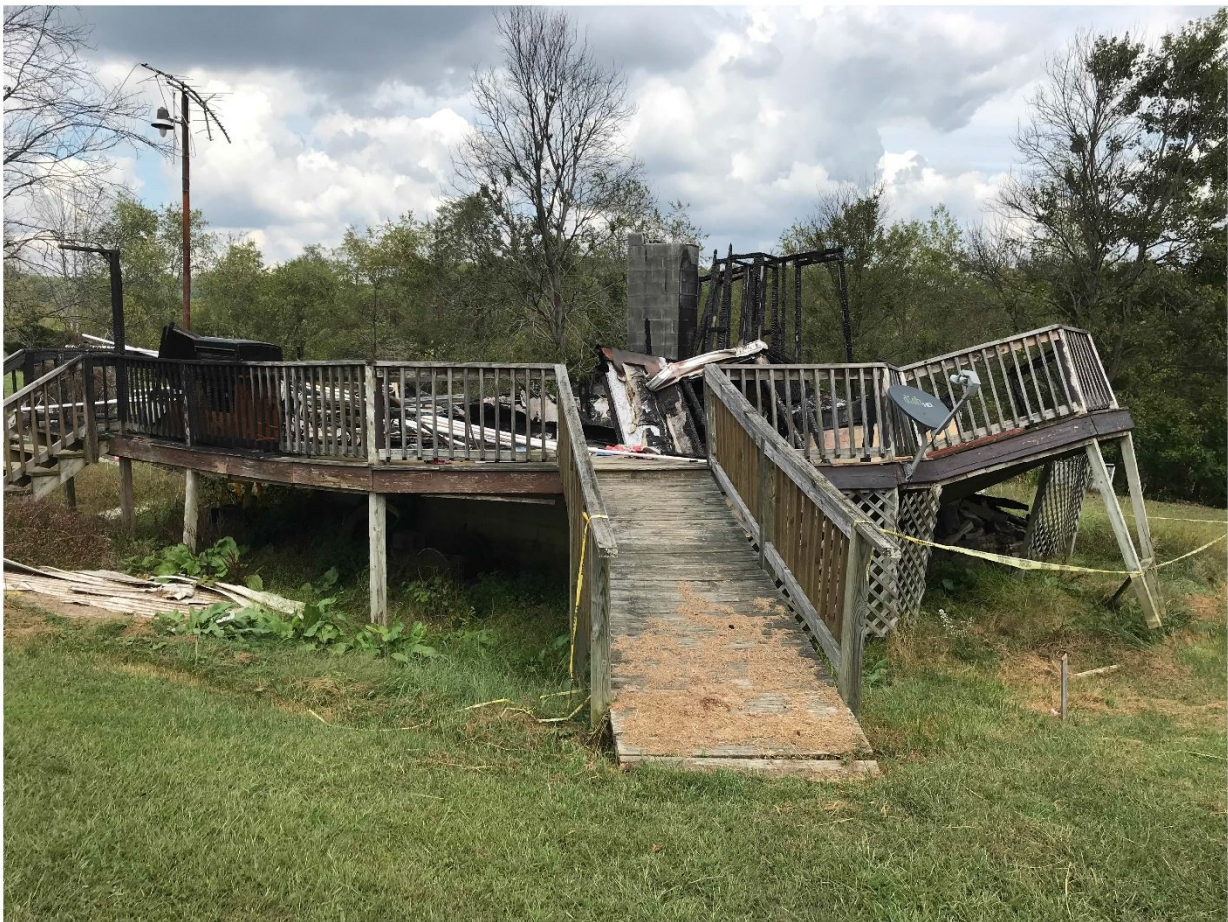
Once all three of them were outside, Mr. White recalled turning around and seeing everything engulfed in flames. They made their way to the neighbor's house to call 9-1-1.

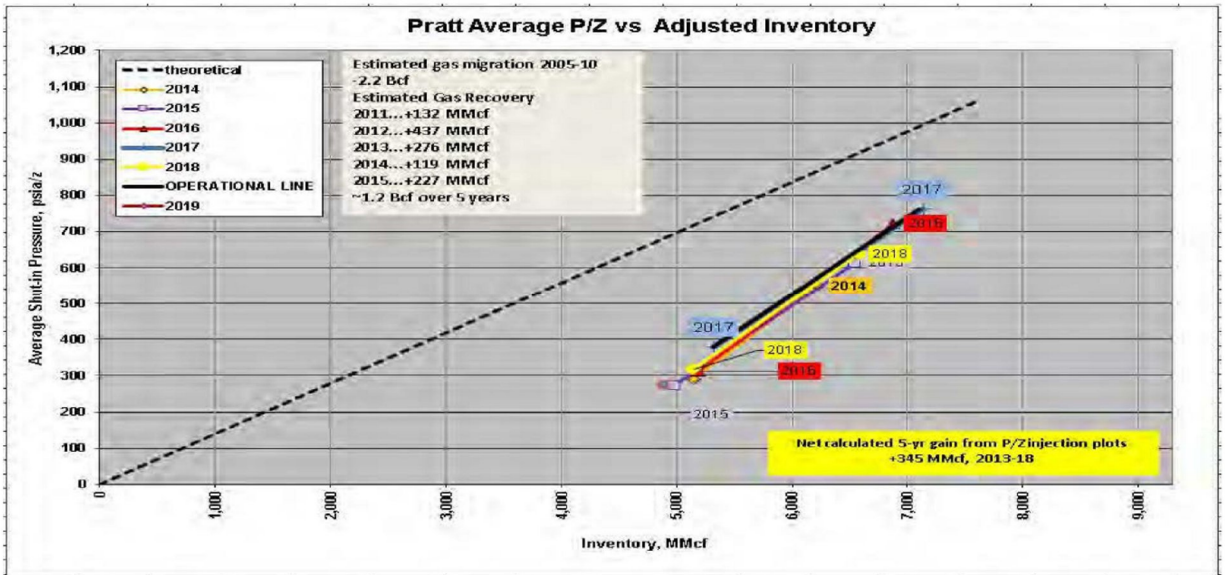
We reviewed the graph that Equitrans engineers use when charting the inventory verifications year after year. We learned from testimony that the dotted black line is the anticipated inventory in the field and that the actual inventory for each year is charted in a different color. The graph shows that, over time, the Pratt field has lost large amounts of gas.

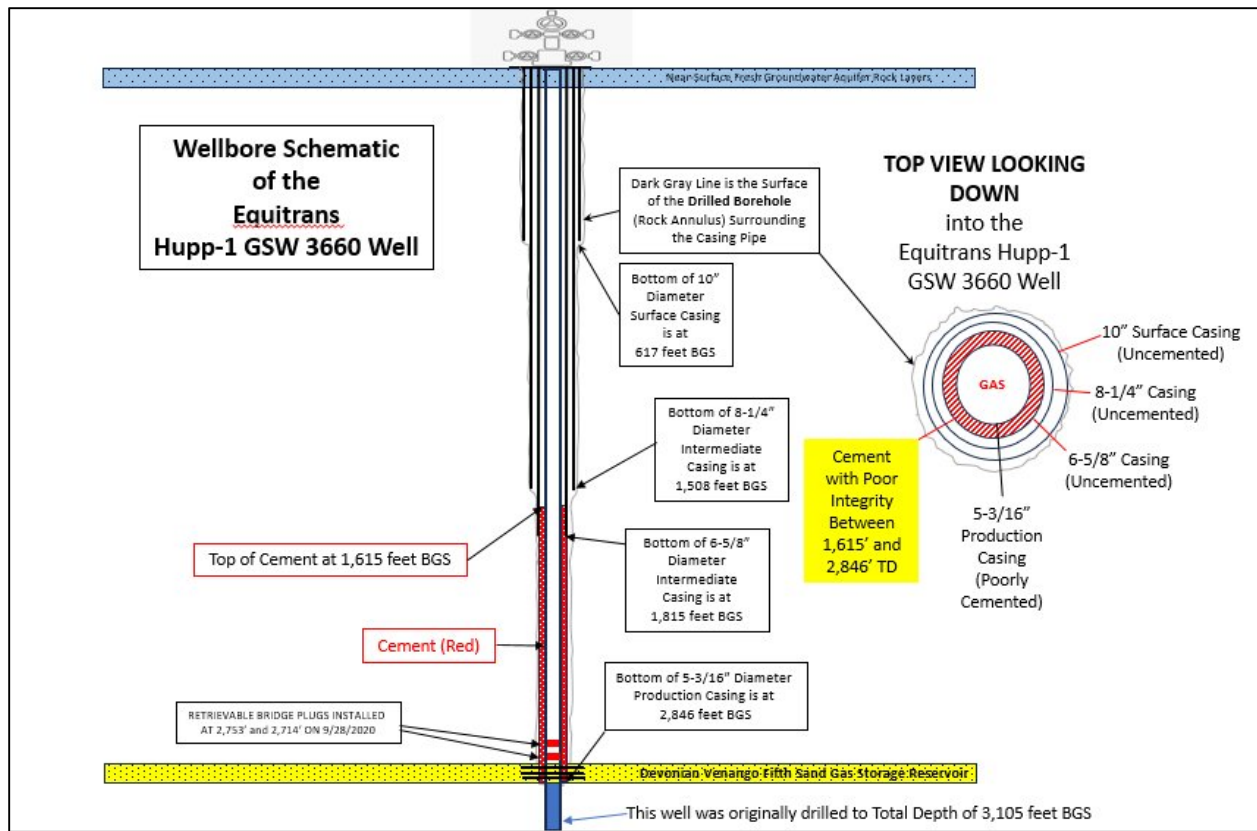
Schematic of Equitrans A.H. Hupp-1 / GSW 3660 Gas Injection / Storage Well

The A.H. Hupp well, also referred to as the 3660 well, was located approximately 300 feet from the White family home. It was originally drilled in 1930. It was reworked in 1951 and then converted to a storage well in 1968. In our review, we learned that the well has four different diameters of pipe. The outermost pipe is 10 ¾ inches in diameter. That pipe starts at the surface and extends to 617 feet below ground. Within that pipe is a smaller pipe that has a diameter of 8 ¼.” That pipe starts at the base of the other casing and extends to 1,508 feet below ground. Next is a 6 5/8” pipe that extends to 1,815 feet below ground. Finally, a 5 3/16” pipe is inserted within the next larger pipe and extends from that depth to the total depth of the well—2,846 feet below ground surface. We learned that the 3660 well only has cement in the innermost space between the smallest pipe and the next larger pipe. The cement was poured only between a depth of 2,846 feet and 1,615 feet. Above 1,615 feet, that innermost space is not cemented, and is open to air. The remaining annular spaces, between the larger diameter casings, never had any cement placed in them.

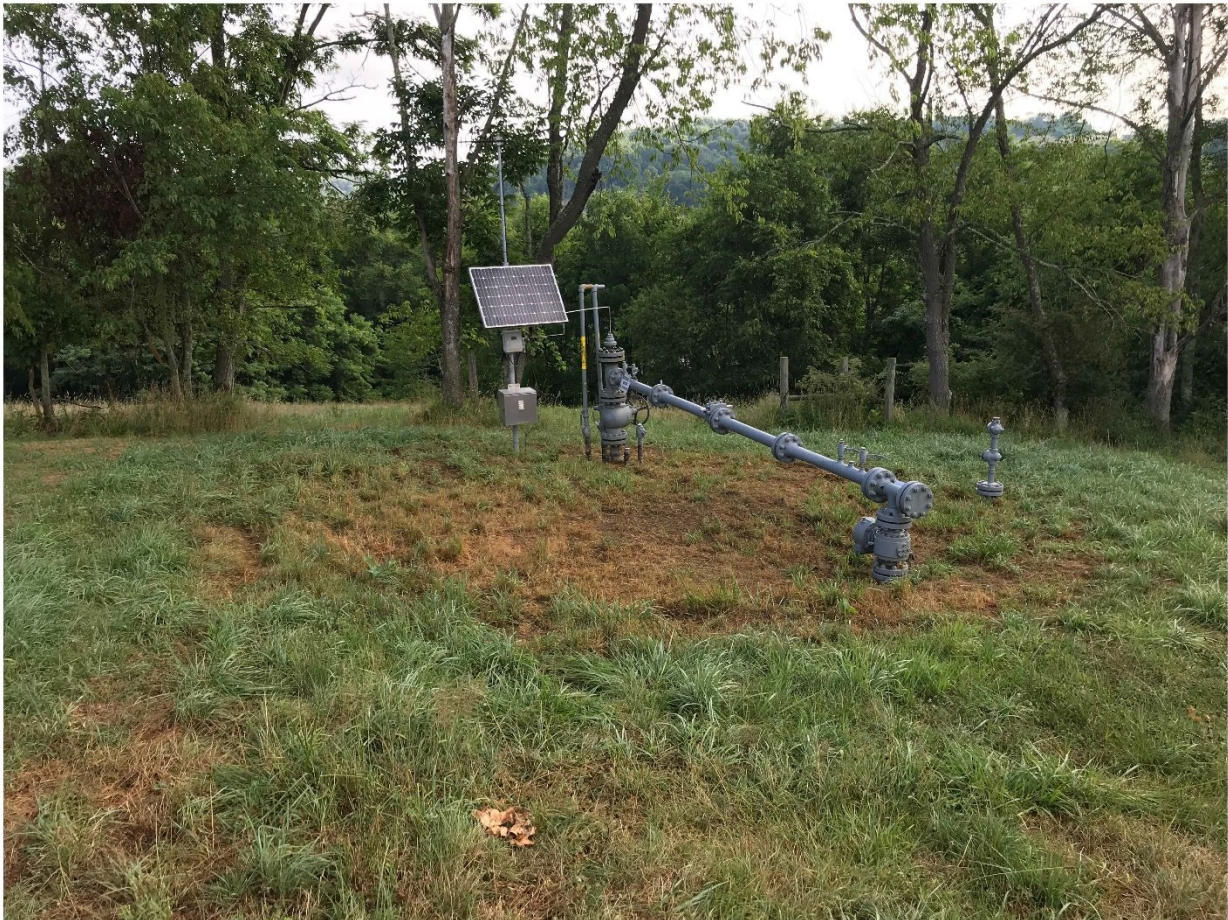
We learned that Pennsylvania Department of Environmental Protection (DEP) employees inspected the 3660 well on various occasions and found evidence of methane leaking. On July 17, 2020, DEP personnel at the site photographed areas of stressed vegetation around the well.

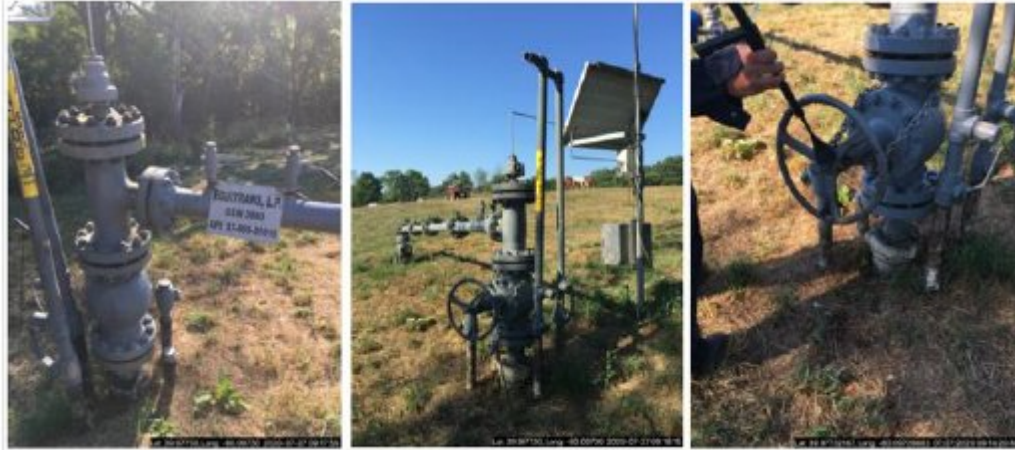
A formal inspection occurred on July 27, 2020. At this time, DEP found the main well valve to be leaking. DEP measured 3700 ppm of methane. It was also discovered that 70% of the air coming out of the inner annular vent was methane. In Equitrans’ response to DEP’s inspection, the company claimed that a bird’s nest inside one of the vents was the cause of the methane that was detected. Additional photographs were taken of the dead vegetation around the well.

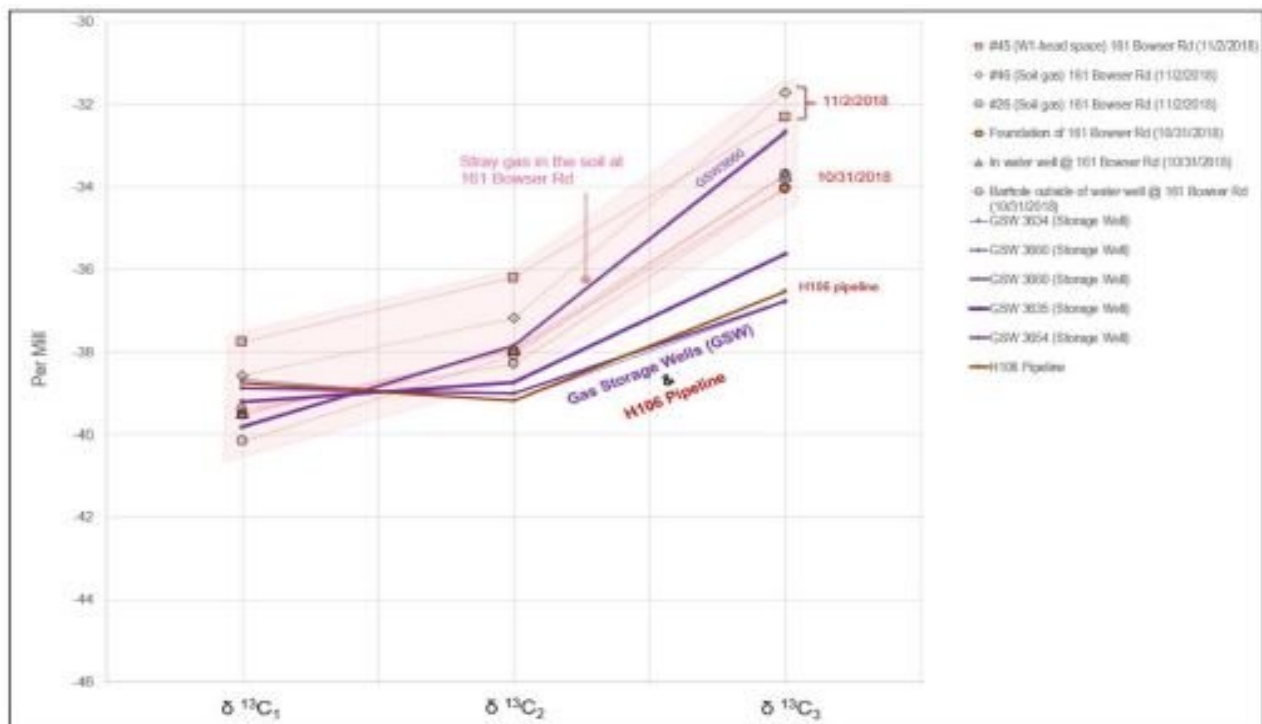
Road, both in the water well and in the soil. It can be seen in the below chart as the purple line that falls within the red shaded area.¹ The red area on the chart is indicative of the stray gas that was found in the soil and water well. We learned that any isotopic samples of gas that fall within this area are potential matches to the stray gas.

Figure 11. One gas storage well sample has some isotopic similarity to the stray gas; however, the other gas storage well samples and the pipeline gas (representative of a statistical mix of all storage field gas samples) do not resemble the stray gas.
